Prestons Park Subdivision GEOTECHNICAL REPORT FOR LOT 1034 CDL Land NZ Limited

21 November 2022 Revision: 1 Reference: 235361

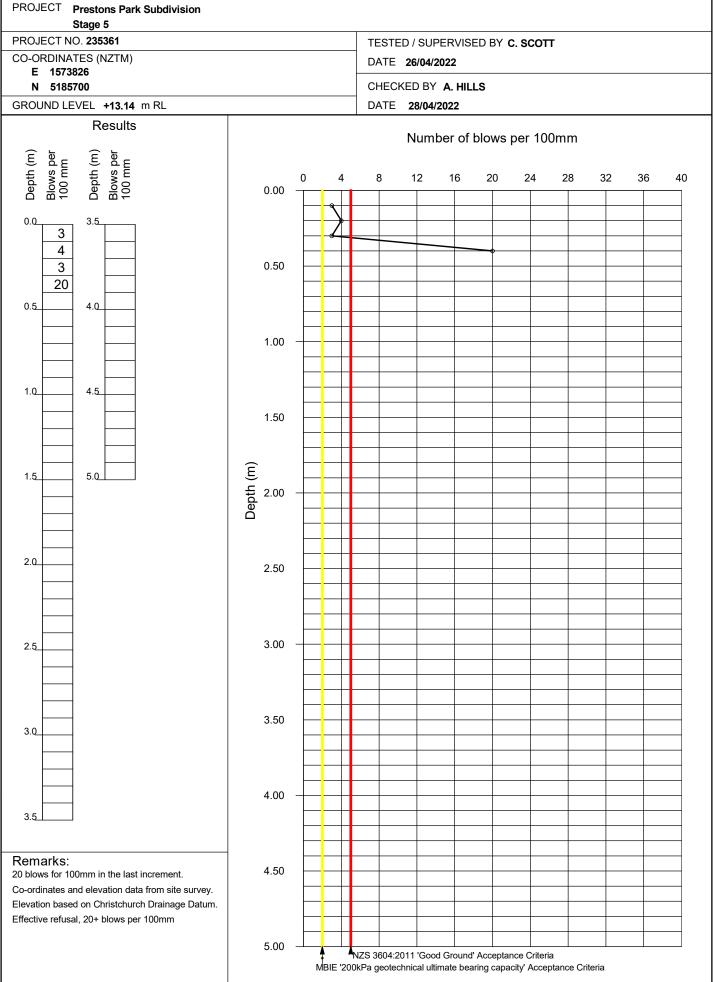
Lot 1034 - DCP1

DCP logs indicate two blows per 100mm penetration, which is equivalent to an ultimate bearing capacity of 200kPa, was consistently encountered from a shallow depth.
