Prestons Park Subdivision
GEOTECHNICAL REPORT FOR LOT 1037
CDL Land NZ Limited

28 November 2022
Revision: 1
Reference: 235361

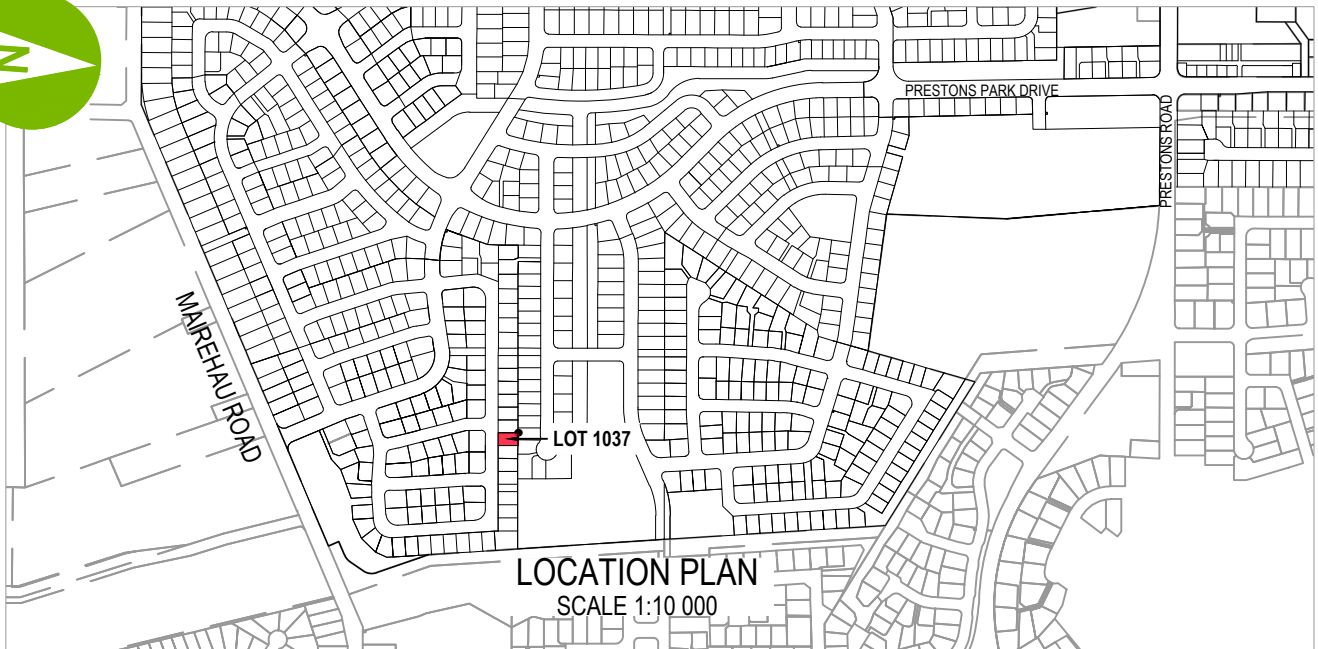
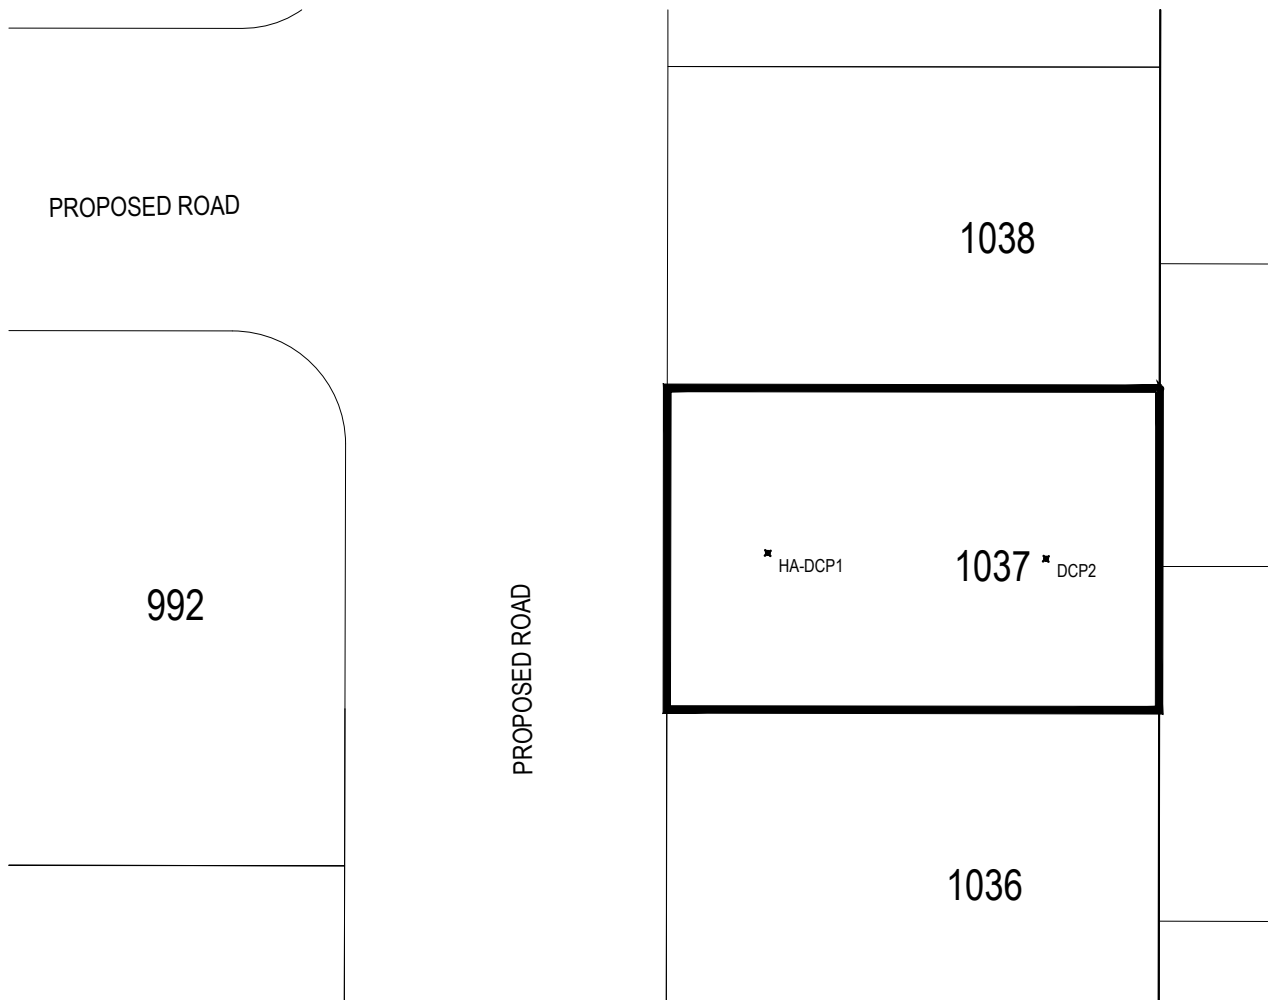
This building consent report is for Lot 1037 which is located in Stage 5 of the Prestons Park Subdivision development (refer Figure 1 in Appendix A). The lot is bordered by residential lots to the north, east and west, with an access road to the south.

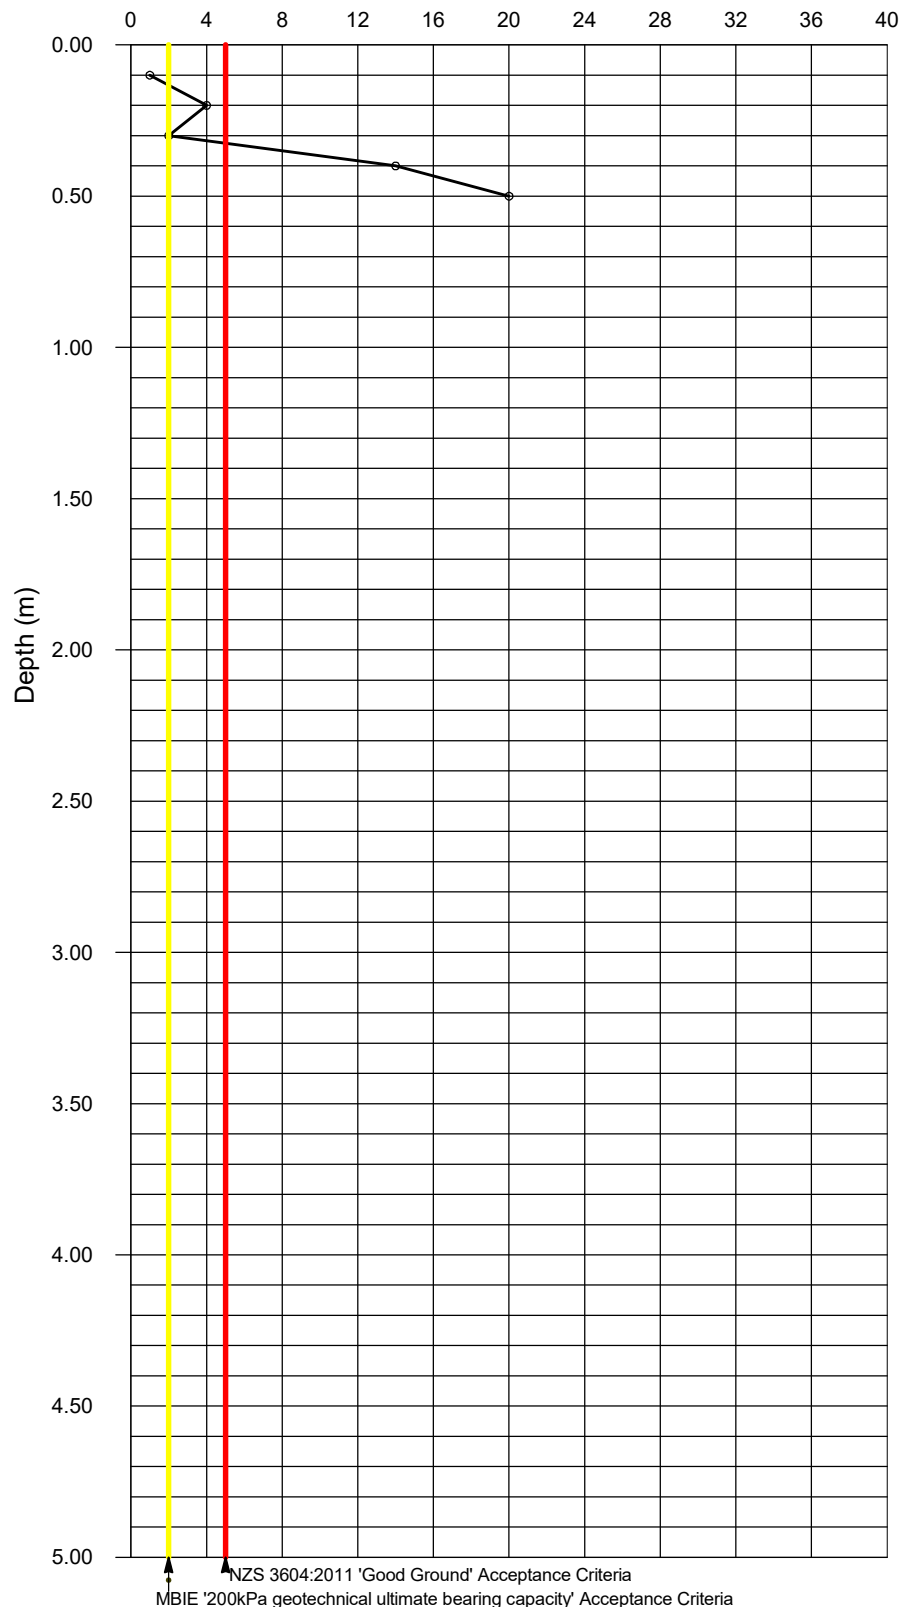
DCP logs indicate 5 blows per 100mm penetration, which is equivalent to an ultimate bearing capacity of 300kPa, was consistently encountered from a depth of 0.4m.

Depth (m)	Blows per 100 mm	Depth (m)	Blows per 100 mm
0.0	1	3.5	
	4		
	2		
	14		
0.5	20	4.0	
1.0		4.5	
1.5		5.0	
2.0			
2.5			
3.0			
3.5

20 blows for 100mm in the last increment.

Effective refusal, 20+ blows per 100mm

Based on our understanding of the site works and the investigation results, we recommend that NZS3604:2011 compliant foundations are embedded a minimum depth of 0.4m below current ground level.

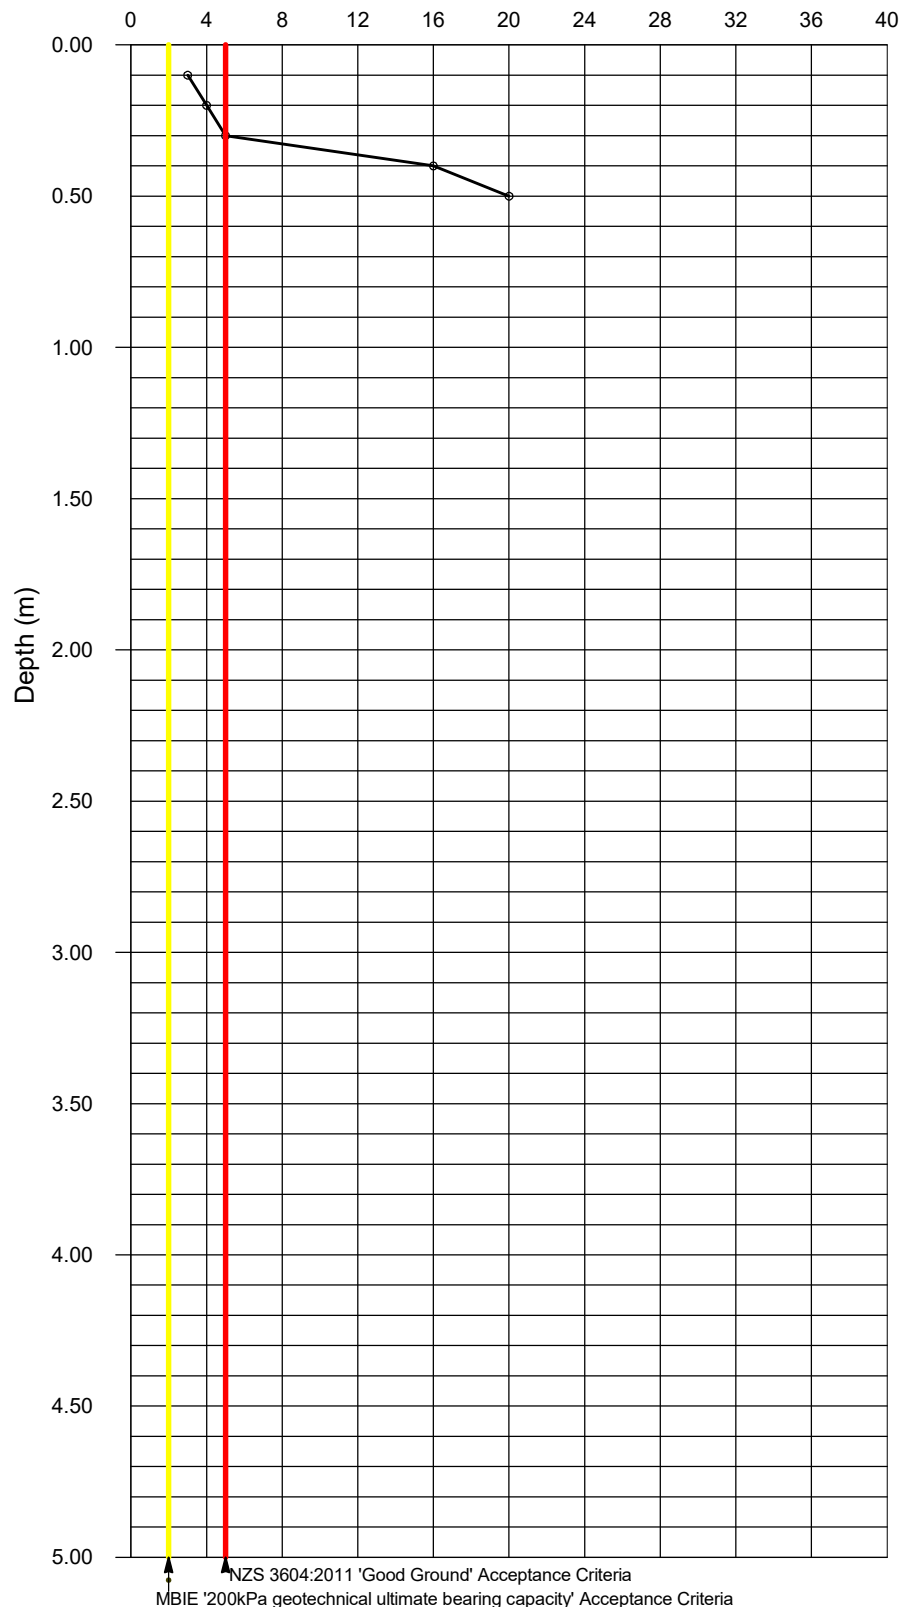
Depth (m)	Blows per 100 mm	Depth (m)	Blows per 100 mm
0.0	3	3.5	
	4		
	5		
	16		
0.5	20	4.0	
1.0		4.5	
1.5		5.0	
2.0			
2.5			
3.0			
3.5

20 blows for 100mm in the last increment.

Effective refusal, 20+ blows per 100mm
