Prestons Park Subdivision  
GEOTECHNICAL REPORT FOR LOT 970  
CDL Land NZ Limited

4 July 2023  
Revision: 1  
Reference: 235361

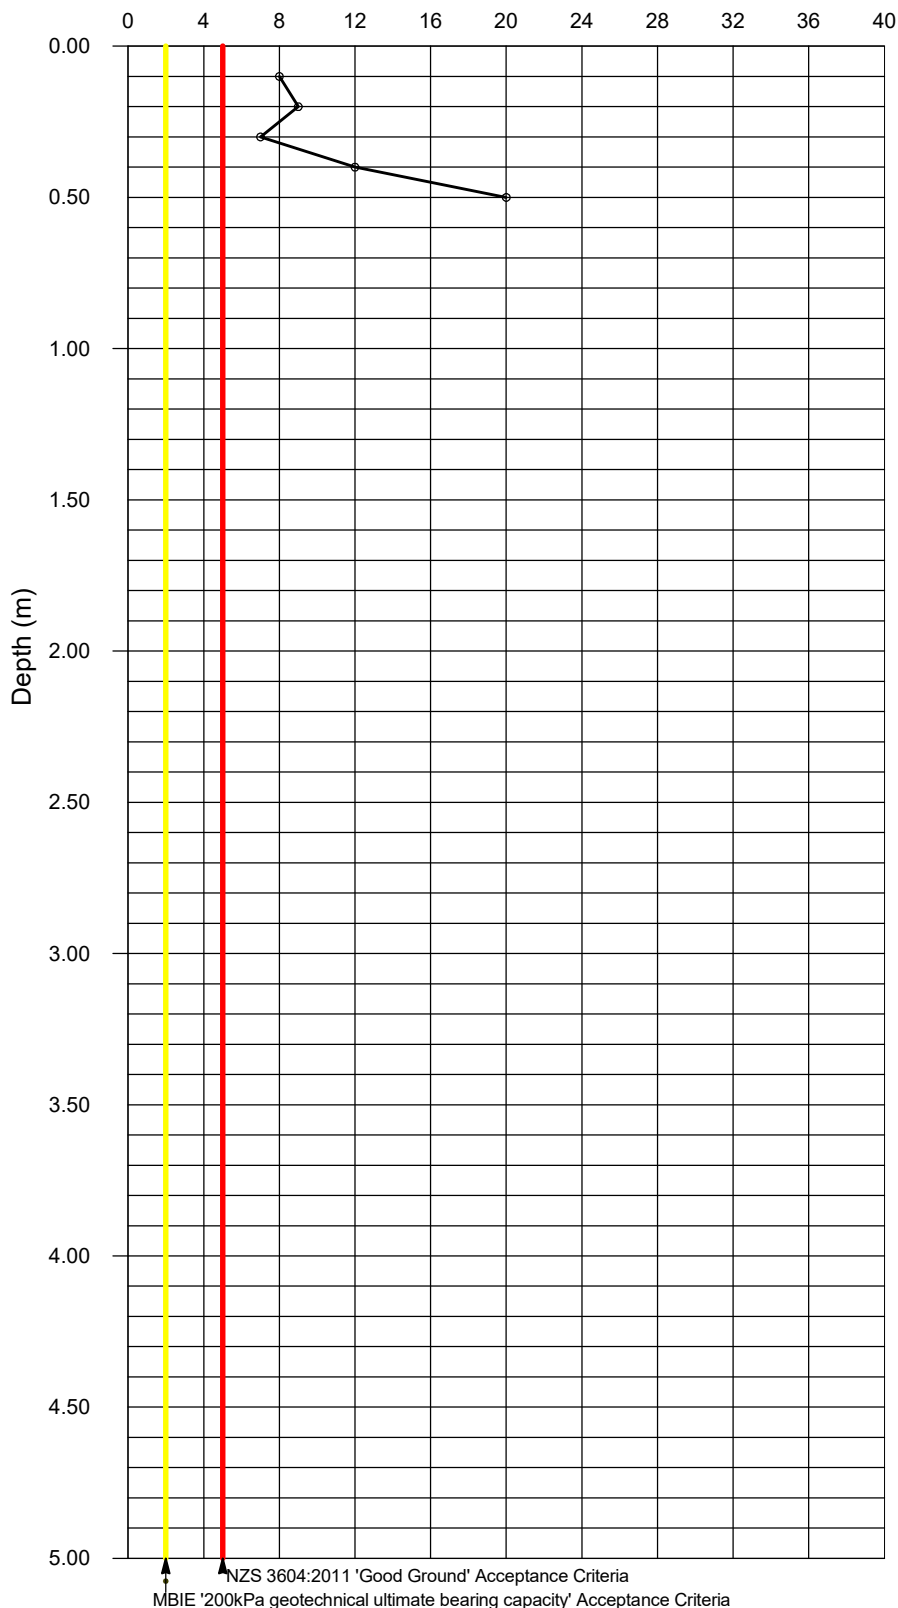
DCP logs indicate 5 blows per 100mm penetration, which is equivalent to an ultimate bearing capacity of 300kPa, was consistently encountered from a shallow depth.

Depth (m)	Blows per 100 mm	Depth (m)	Blows per 100 mm
0.0	8	3.5	
	9		
	7		
	12		
0.5	20	4.0	
1.0		4.5	
1.5		5.0	
2.0			
2.5			
3.0			
3.5

20 blows for 100mm in the last increment.

Effective refusal, 20+ blows per 100mm.

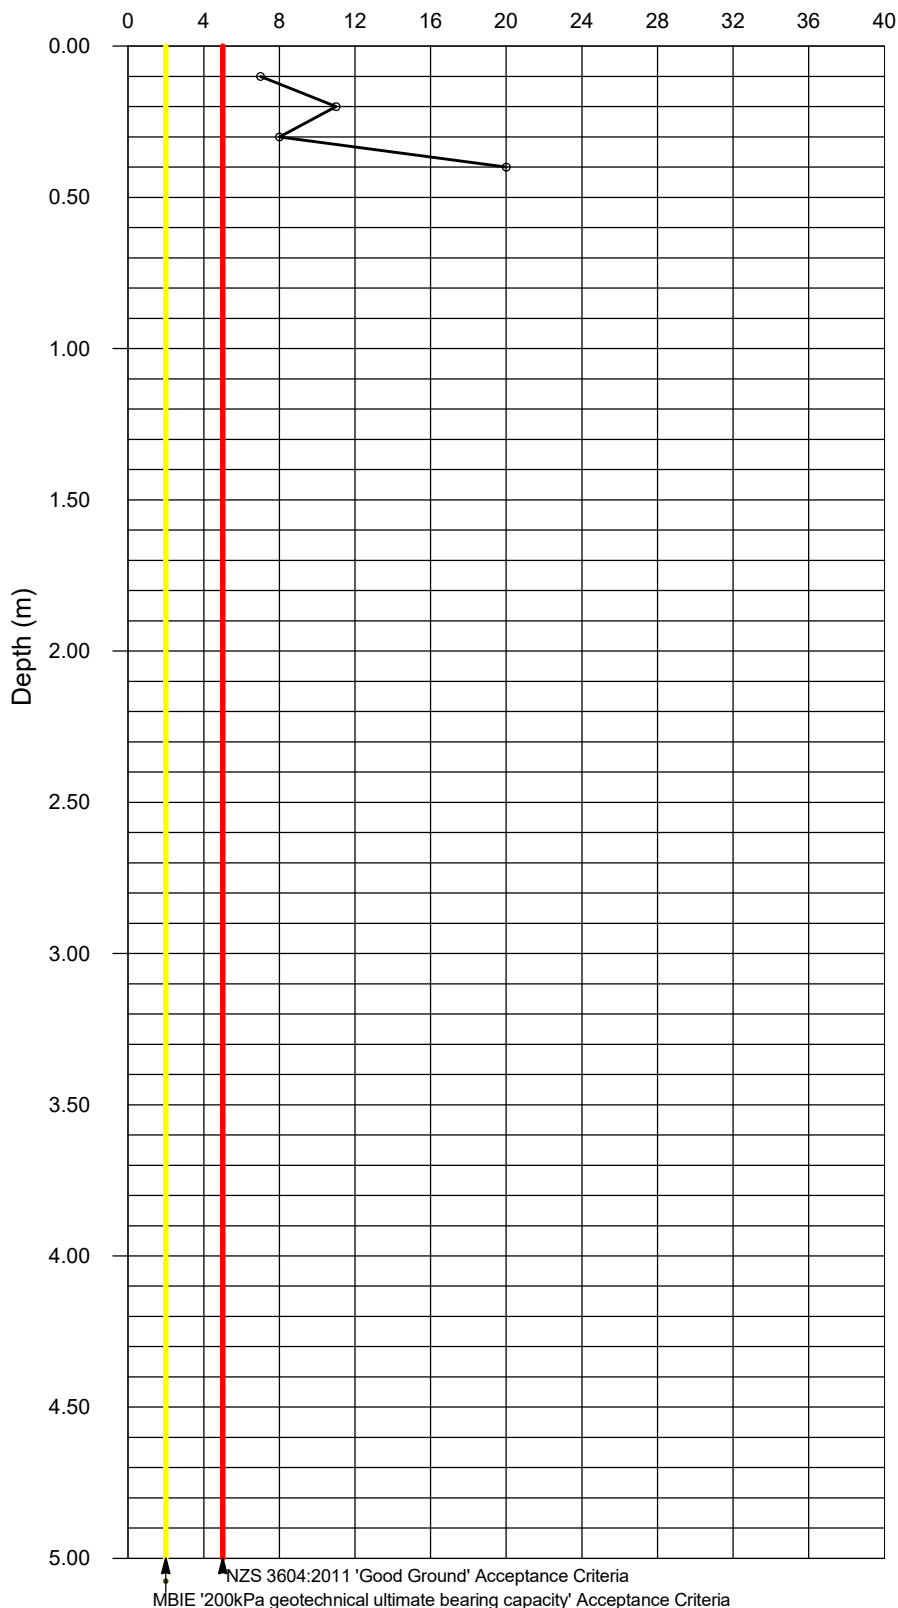
Depth (m)	Blows per 100 mm	Depth (m)	Blows per 100 mm
0.0	7	3.5	
	11		
	8		
	20		
0.5		4.0	
1.0		4.5	
1.5		5.0	
2.0			
2.5			
3.0			
3.5

20 blows for 100mm in the last increment.

Effective refusal, 20+ blows per 100mm.
