Prestons Park Subdivision  
GEOTECHNICAL REPORT FOR LOT 948  
CDL Land NZ Limited

30 June 2023  
Revision: 1  
Reference: 235361

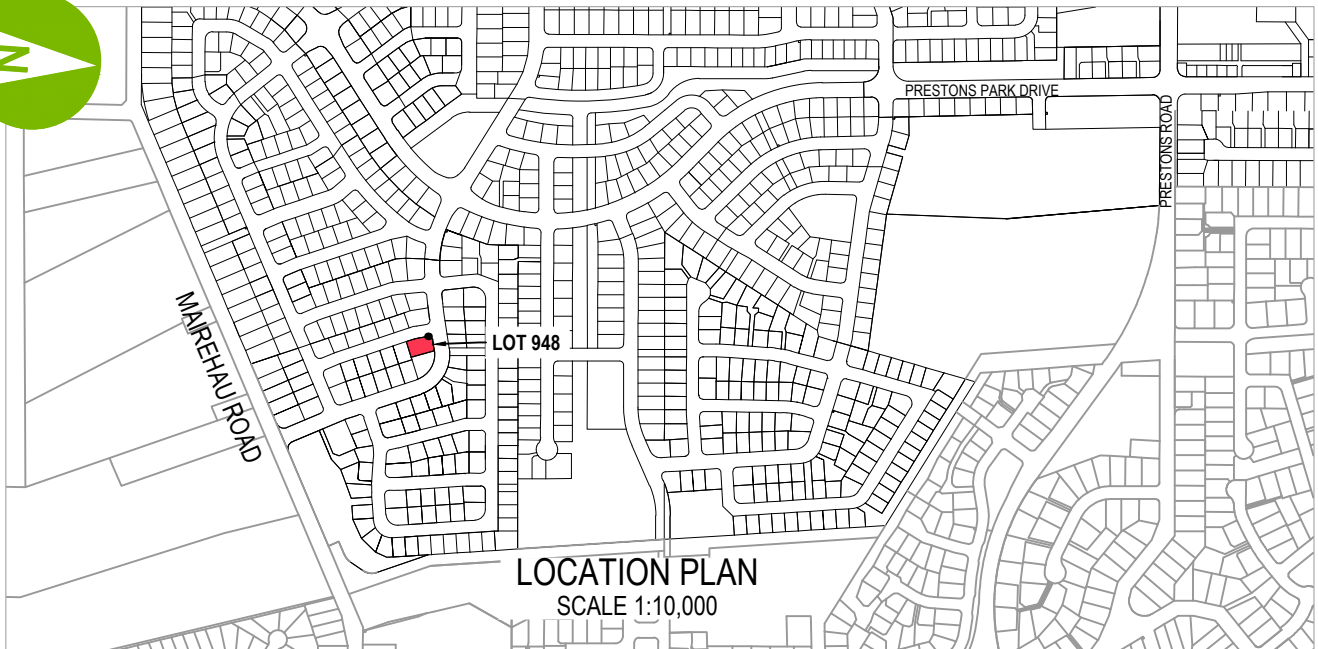
TITLE  
**LOT 948  
SITE LOCATION PLAN  
FIGURE 1**

This building consent report is for Lot 948 which is located in Stage 5 of the Prestons Park Subdivision development (refer Figure 1 in Appendix A). The lot is bordered by residential lots to the east and south, with road access to the north and west.
