Prestons Park Subdivision
GEOTECHNICAL REPORT FOR LOT 966
CDL Land NZ Limited

28 June 2023
Revision: 1
Reference: 235361

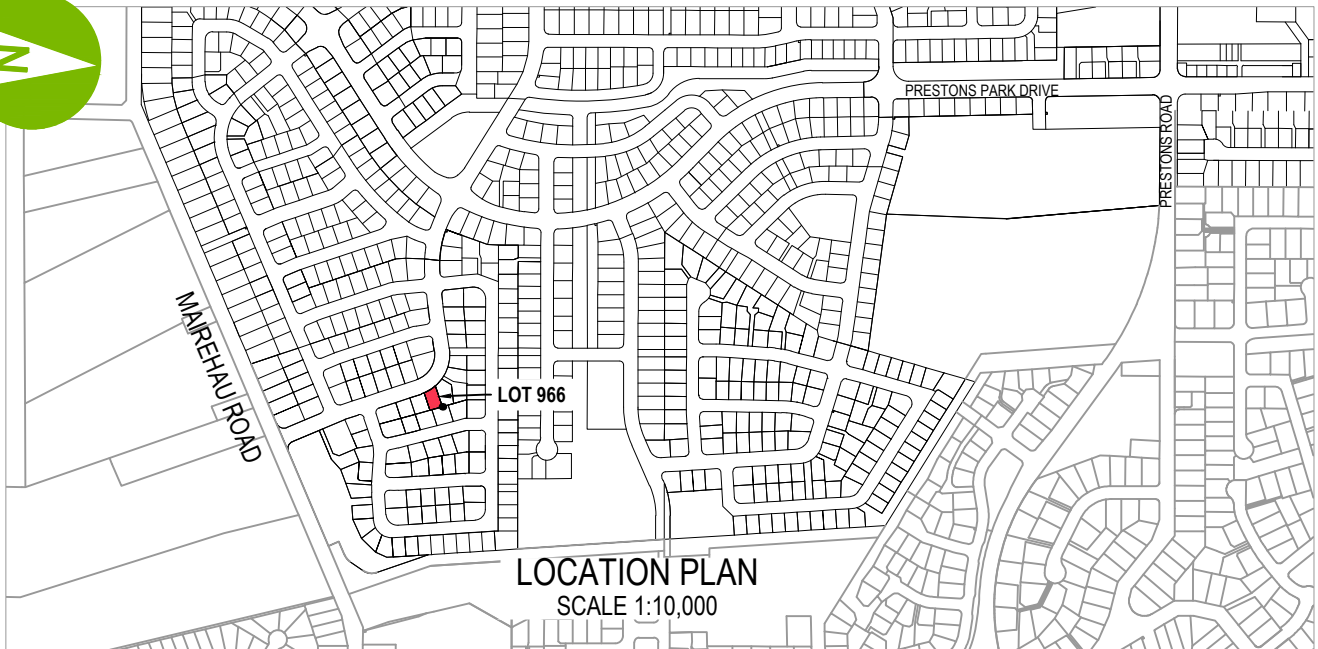
TITLE
**LOT 966
SITE LOCATION PLAN
FIGURE 1**

This building consent report is for Lot 966 which is located in Stage 5 of the Prestons Park Subdivision development (refer Figure 1 in Appendix A). The lot is bordered by residential lots to the north, south and east, with road access to the west.
