Prestons Park Subdivision
GEOTECHNICAL REPORT FOR LOT 973
CDL Land NZ Limited

28 June 2023
Revision: 1
Reference: 235361

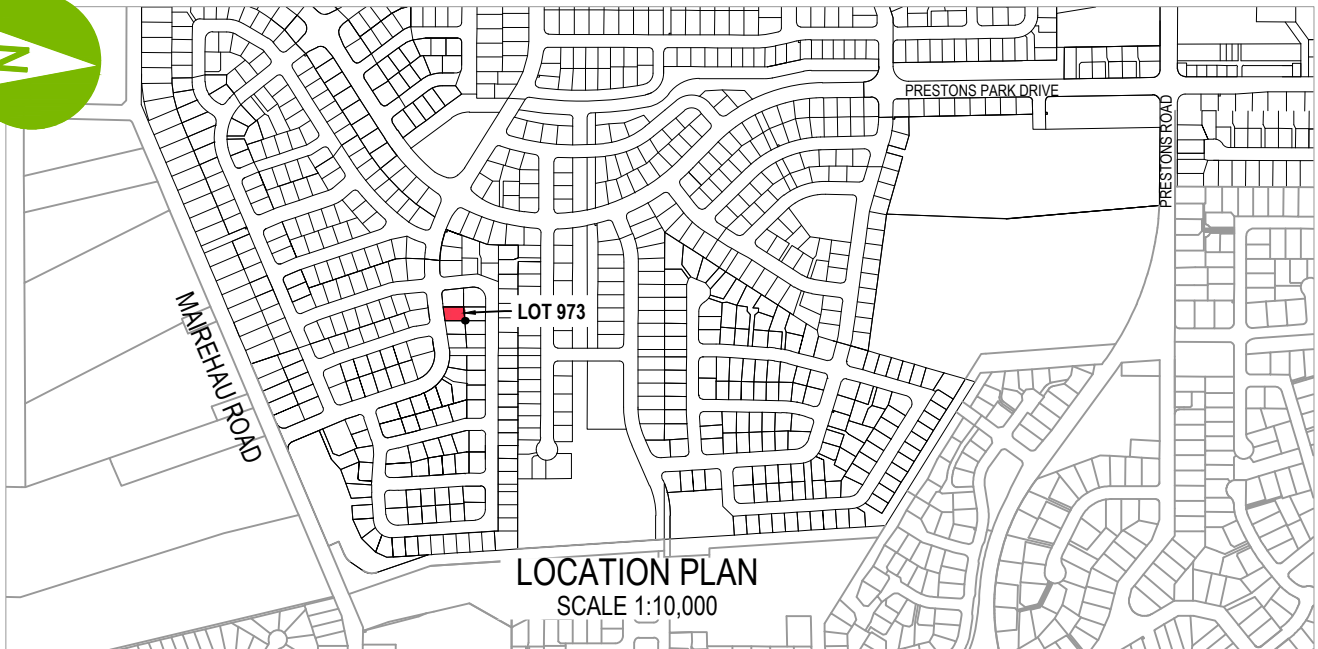
TITLE
**LOT 973
SITE LOCATION PLAN
FIGURE 1**

This building consent report is for Lot 973 which is located in Stage 5 of the Prestons Park Subdivision development (refer Figure 1 in Appendix A). The lot is bordered by residential lots to the north, east and west, with road access to the south.
