Prestons Park Subdivision
GEOTECHNICAL REPORT FOR LOT 942
CDL Land NZ Limited

26 June 2023
Revision: 1
Reference: 235361

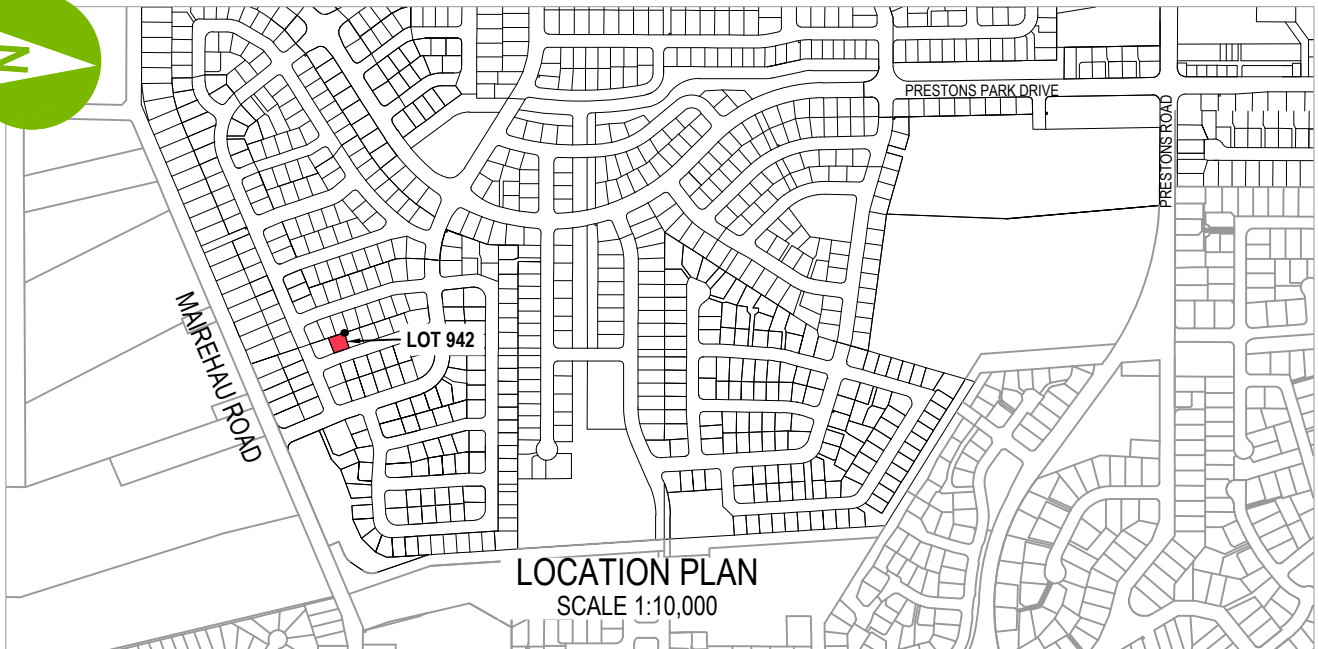
TITLE
LOT 942 SITE LOCATION PLAN FIGURE 1

This building consent report is for Lot 942 which is located in Stage 5 of the Prestons Park Subdivision development (refer Figure 1 in Appendix A). The lot is bordered by residential lots to the east, south and north, with access roads to the east.
