Prestons Park Subdivision
GEOTECHNICAL REPORT FOR LOT 943
CDL Land NZ Limited

26 June 2023
Revision: 1
Reference: 235361

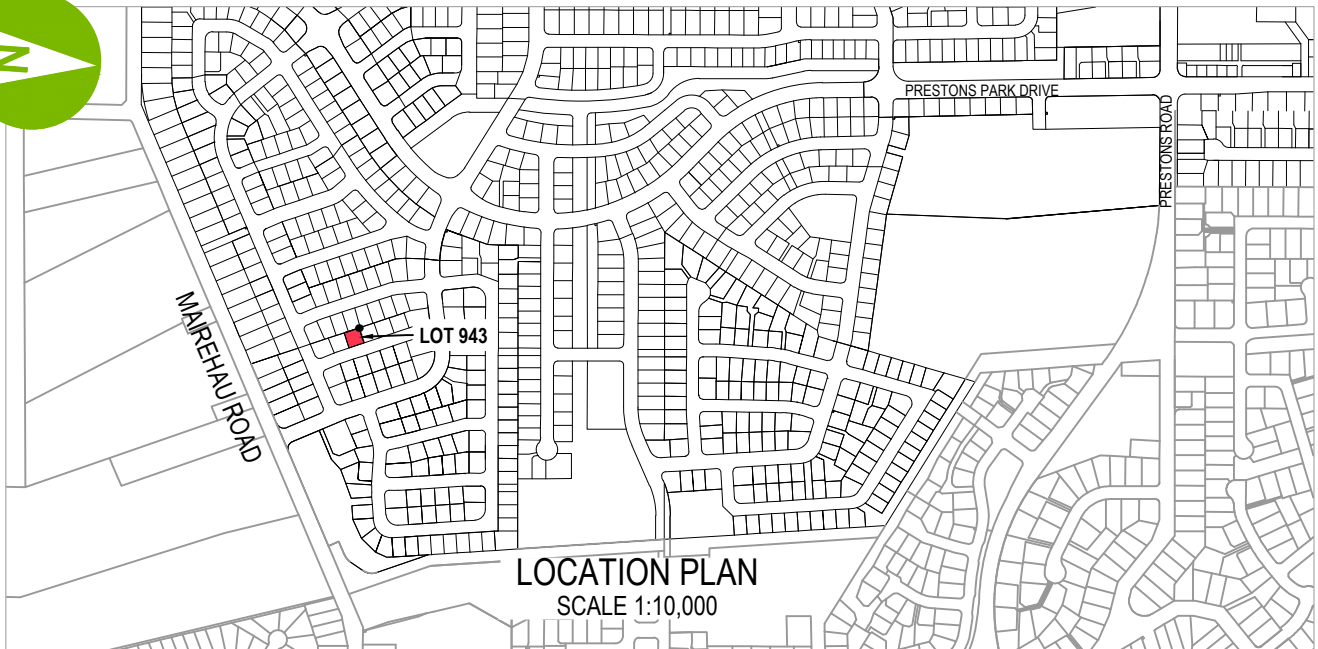
This building consent report is for Lot 943 which is located in Stage 5 of the Prestons Park Subdivision development (refer Figure 1 in Appendix A). The lot is bordered by residential lots to the west, north and south, with access roads to the east.
